SUBJECT: STRAIT OF JUAN DE FUCA WAMS (13004)

STRAIT OF JUAN DE FUCA
WAMS ANALYSIS
GROUP PORT ANGELES
DISTRICT IDENTIFICATION NUMBER 13004
CRITICAL WATERWAY
JUNE 1995

Subj: STRAIT OF JUAN DE FUCA WAMS DATED JUNE 1995

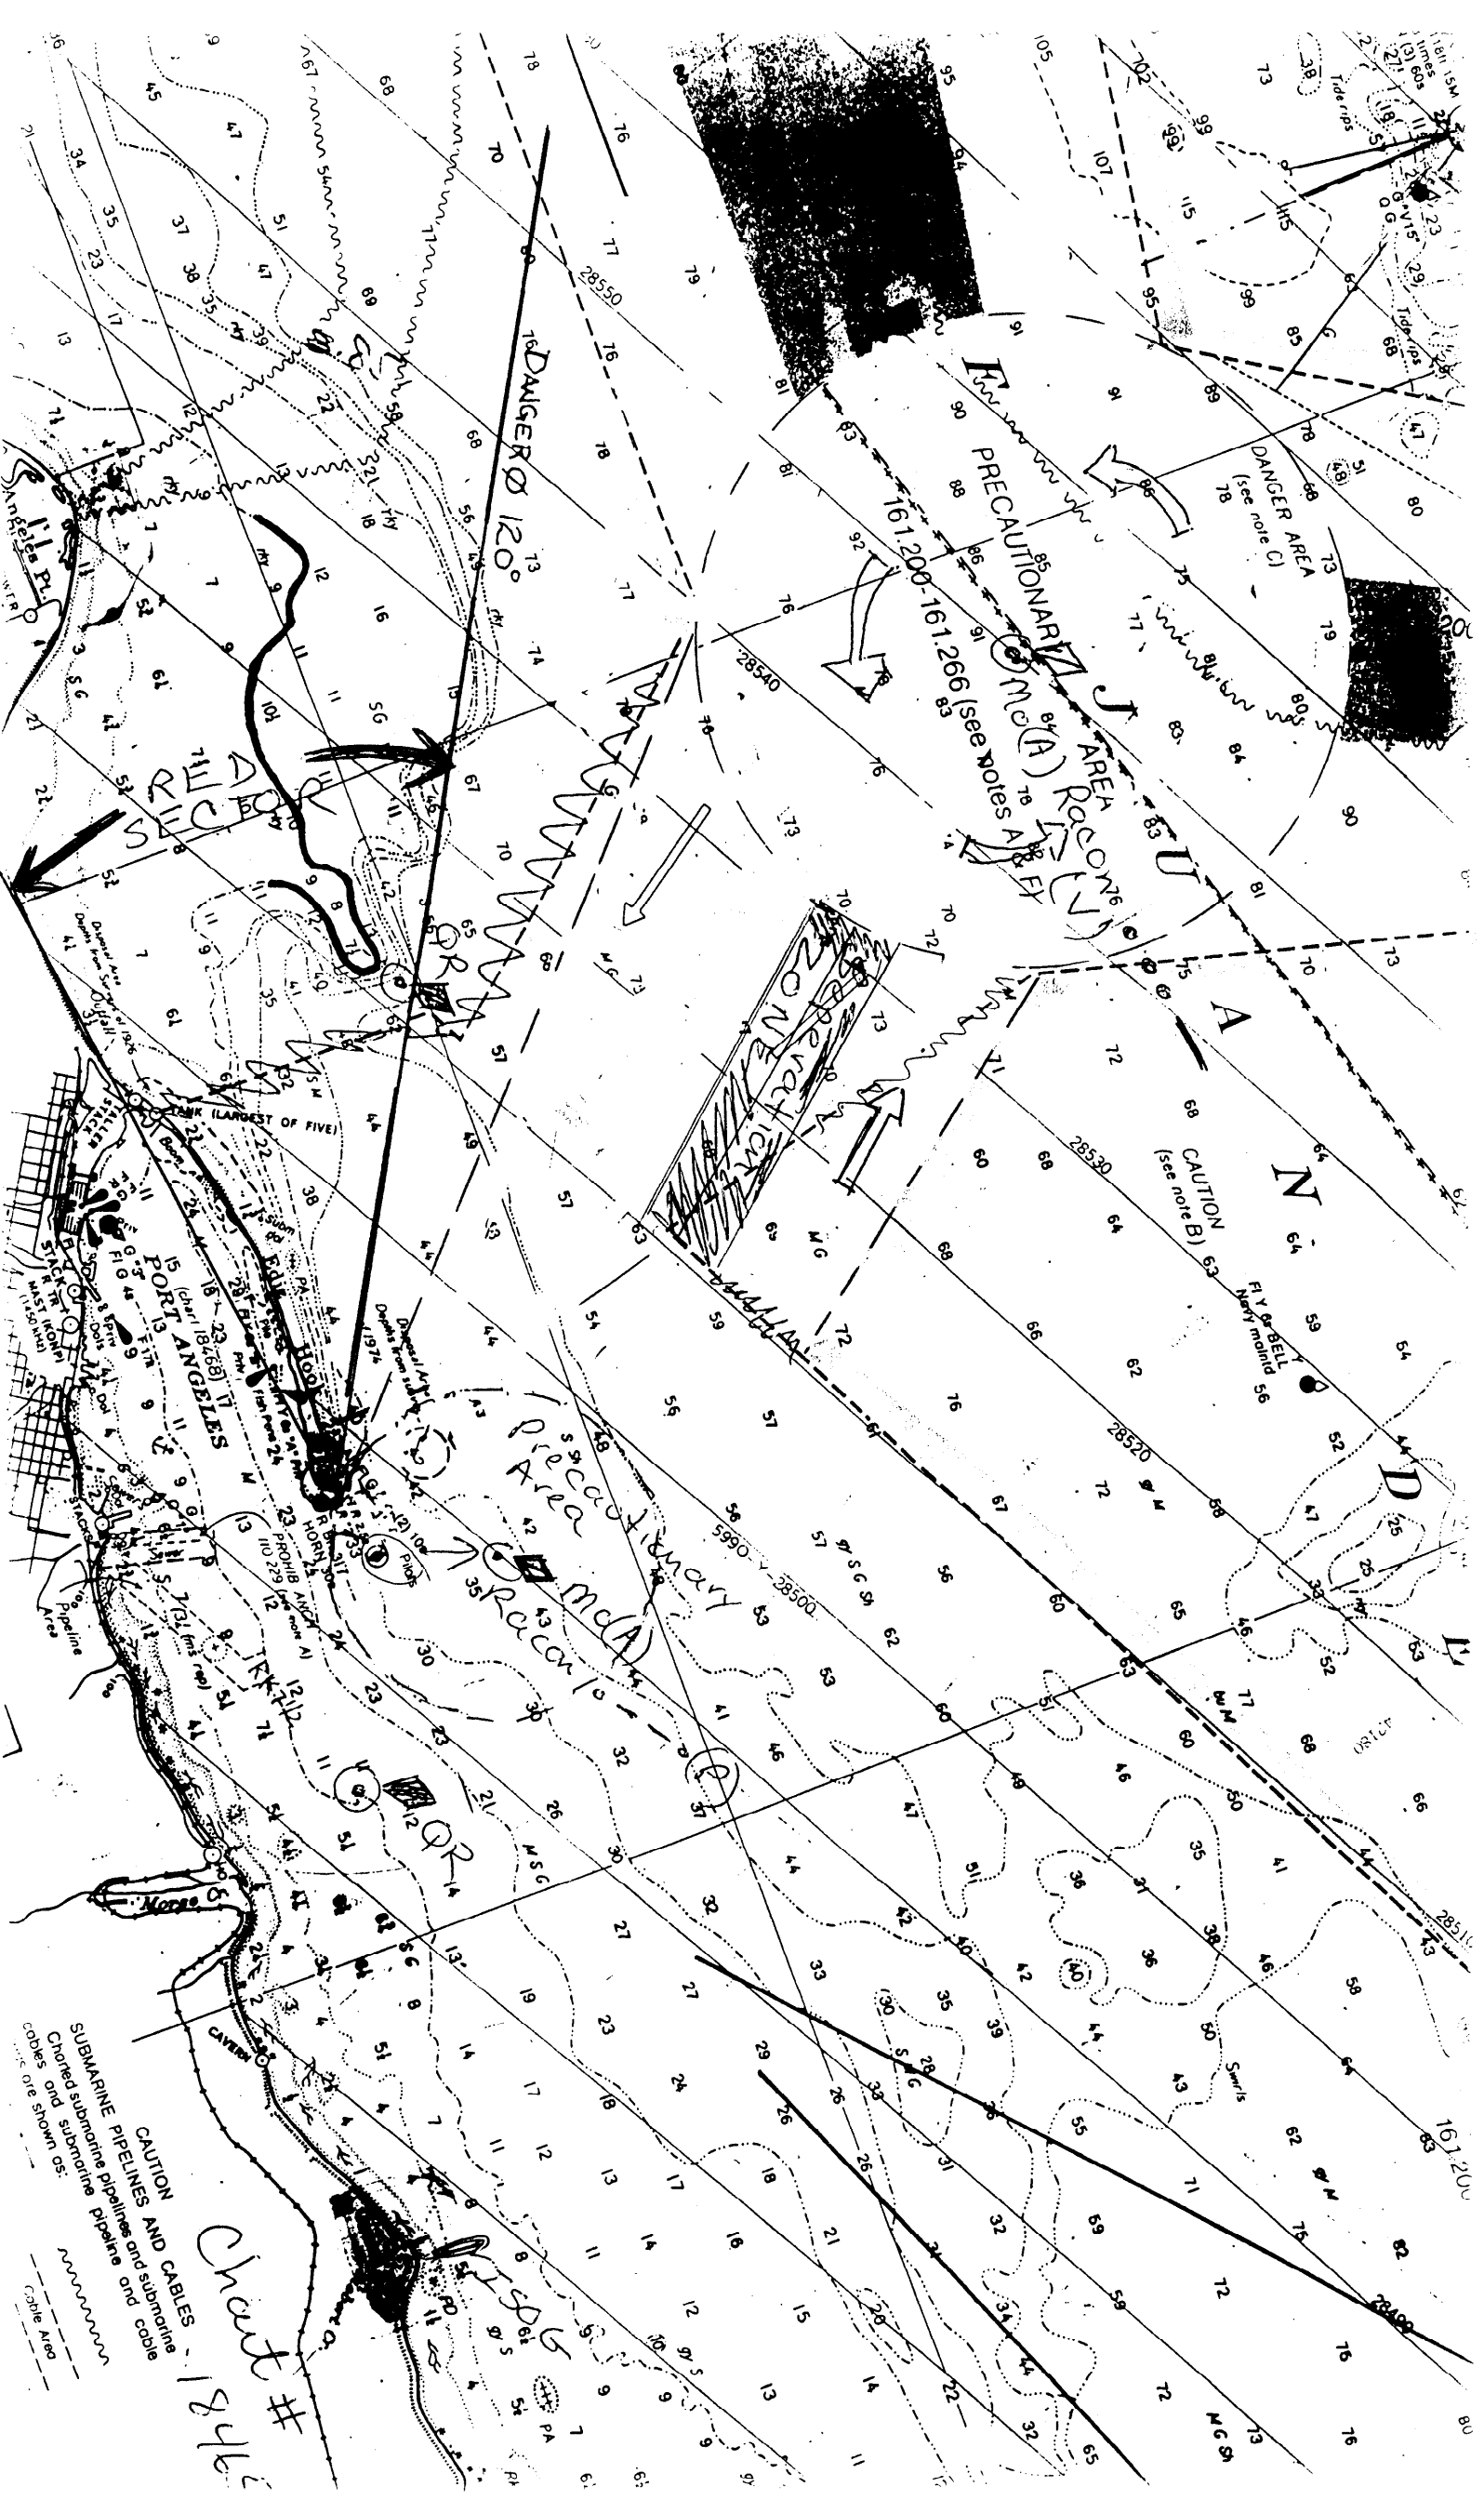
C. Establish lighted buoy with QR characteristics around L 48-09.8 N and Long. 123-28.2 W, (See Chartlet). This would mark the northeasternmost limit of the shoal that is between Angeles Point and Ediz Hook. This would be a fail safe measure over the red sector on Port Angeles Light.

F. Now for the major items. As has been said before, embarking and disembarking pilots off Ediz Hook is unnecessarily nerve wracking and dangerous. Deep draft ships are forced close to the point, sometimes with a current setting them into shoal water, and meeting inbound or outbound vessels at the same time. Ships must come in too close to the grounding lines, and ships must meet other ships bound in the opposite direction under haphazard conditions. The pilots do not try to space the vessels, nor does VTS. This would help a lot. What I see as one way to achieve greater safety off Ediz Hook is to re-arrange the traffic scheme to match the enclosed chartlet.
